PUBLIC ROADS

JOINTS AND CRACKS IN CONCRETE PAVEMENTS

A COOPERATIVE STUDY BY PUBLIC ROADS ADMINISTRATION AND THE MICHIGAN STATE HIGHWAY DEPARTMENT

Reported by EARL C. SUTHERLAND, Senior Highway Engineer

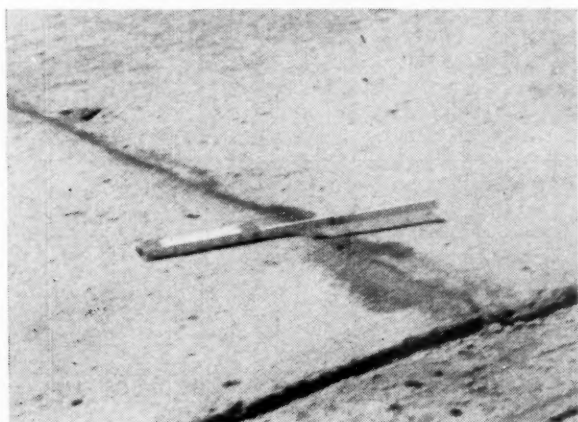
FIGURE 6.—EXPANSION JOINT FAULTED APPROXIMATELY 1 INCH WITH THE SLAB BEYOND THE JOINT DOWN.

There appears to be no uniformity in the direction or manner of the faulting. In many cases the slab beyond the joint was below the approach slab at the free edges of the pavement, while in others the opposite condition was found. The same was true of the two points adjacent to the longitudinal joint. As a general rule, however, the slab beyond the joint was below the approach slab where the faulting was severe, that is, where the relative displacement was one-half inch or more. Such a joint is illustrated in figure 6.

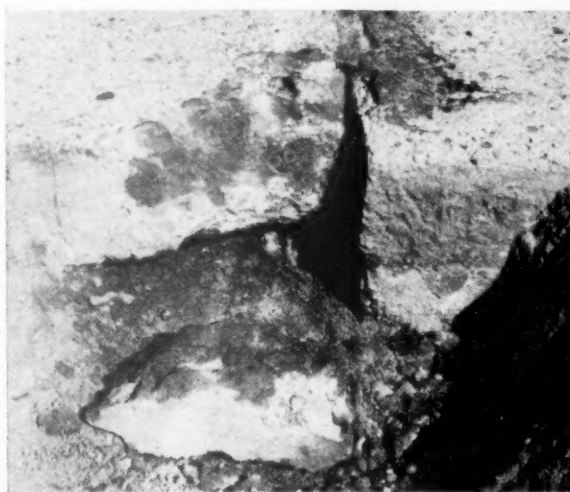
FIGURE 7.—SMALL COMPRESSION CORNER FAILURE AT A CLOSED EXPANSION JOINT.

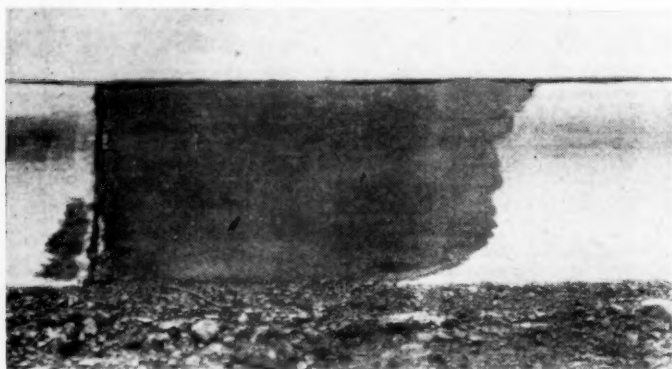
FIGURE 17.—BADLY FAULTED JOINT WITH LEADING SLAB DEPRESSED.

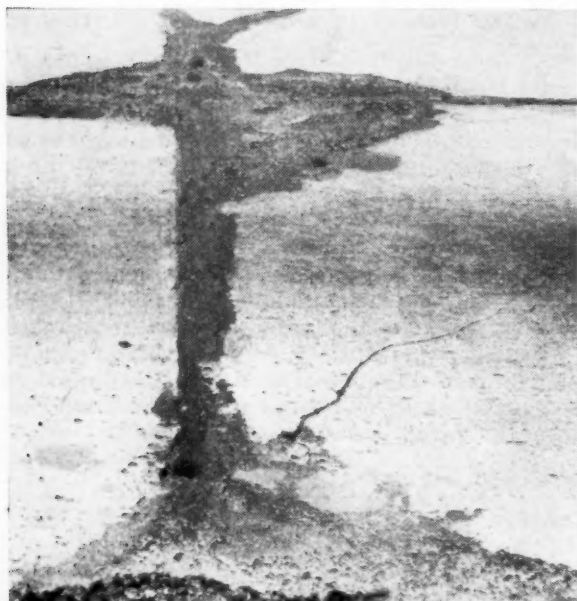
FIGURE 19.—SCALING IN CORNERS FORMED BY EXPANSION JOINT.

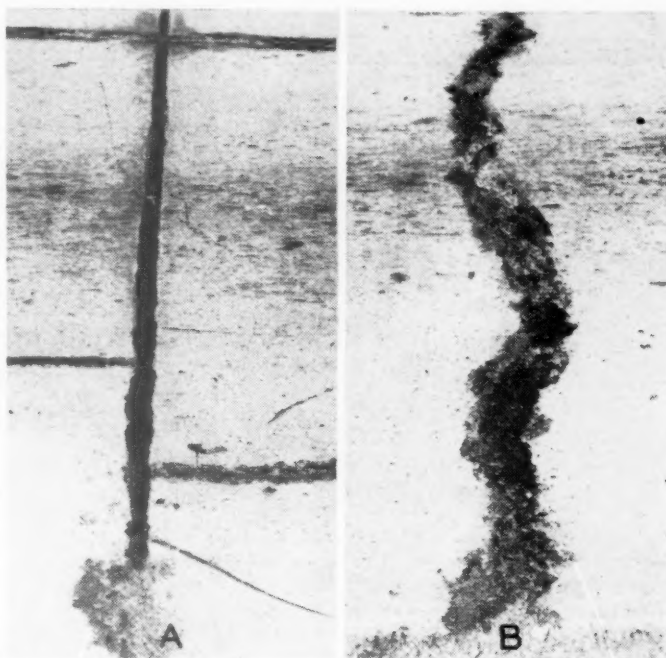
FIGURE 20.—A, NORMAL JOINT IN A TYPICAL OLD PAVEMENT; B, NORMAL CRACK IN A TYPICAL OLD PAVEMENT.

Close-up views of a joint and a crack typical of those on one of the older pavements examined are shown in figure 20. This surface was in better than average condition for pavements of the older group. Some spalling can be noted along the edges of both the joint and the crack. It is typical that the extent of the spalling was greater at the crack than at the joint.

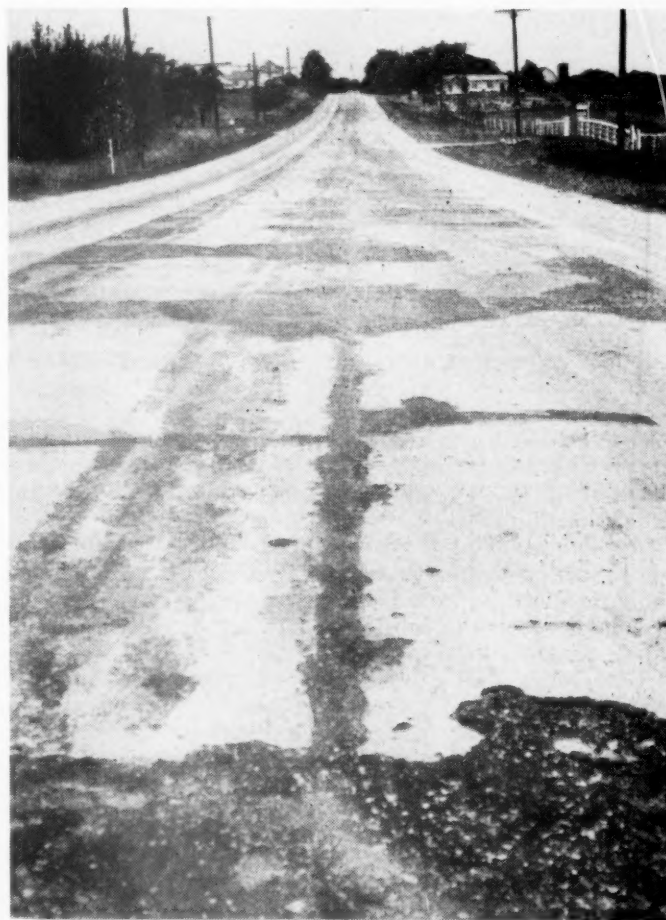
FIGURE 21.—A BADLY SCALED AND DISINTEGRATED PAVEMENT.

A general view of one of the more badly scaled and disintegrated pavements is shown in figure 21. The center and right lane of this pavement were approximately 13 years old, while the left lane was relatively new. The new pavement was in good condition. The scaling and disintegration on the old surface was largely in the vicinity of joints and cracks and especially in the corners formed by the joints and cracks. Figures 22, A, and 22, D show in detail the character of the disintegration which has developed at some of the more badly damaged areas at a crack. Figure 22, B shows similar areas at a joint where bad disintegration had developed.

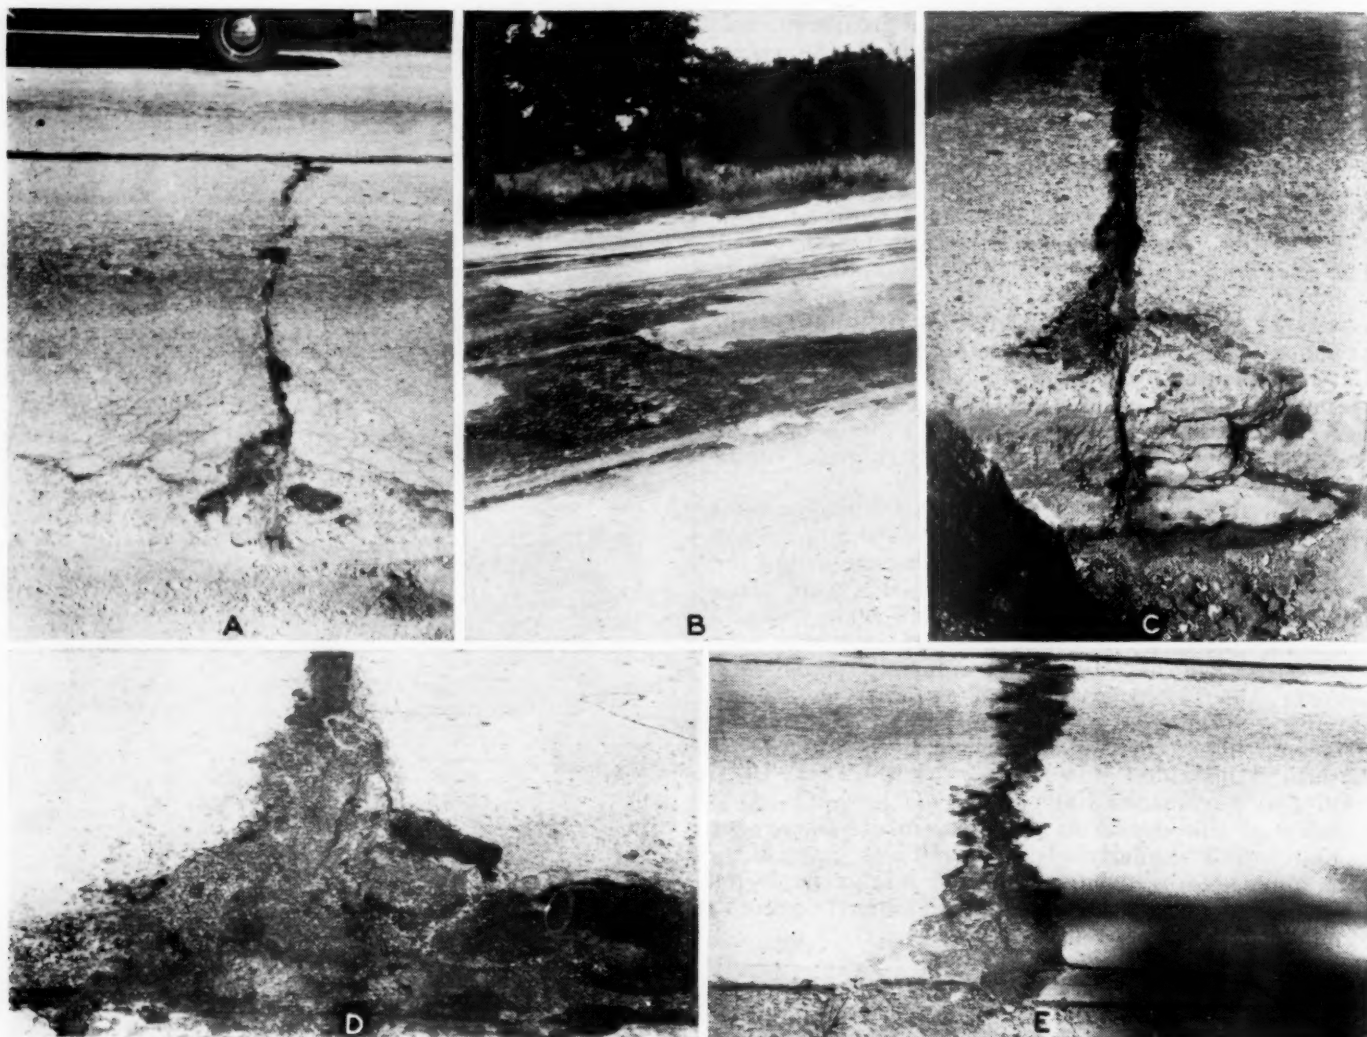
FIGURE 22.—A, SURFACE DISINTEGRATION AT CORNERS FORMED BY CRACK; B, SCALING AT CORNERS FORMED BY JOINT, COVERED WITH CRACK FILLER; C, SMALL CORNER FAILURE AT CLOSED EXPANSION JOINT; D, SCALING AT CORNERS FORMED BY CRACKS COVERED WITH CRACK FILLER; AND E, SMALL CORNER FAILURE AT CORNER FORMED BY CRACK.

The corner breaks shown in figures 22, E and 23, B are typical of a number found at the joints and cracks in the pavements of projects 116 and 91. In both of these pavements continuous plain round edge bars were used. On project 116 expansion joints were spaced at intervals of approximately 50 feet, while on

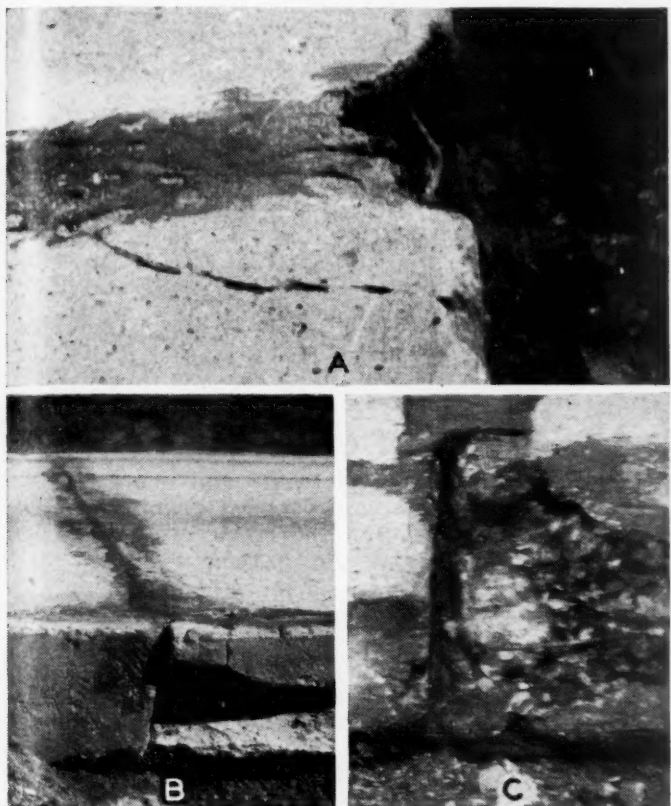
FIGURE 23.—A, BUCKLED EDGE BAR OF A SMALL CORNER FAILURE; B, SMALL CORNER FAILURE AT A JOINT; C, SMALL CORNER FAILURE ON RELATIVELY NEW REINFORCED PAVEMENT.

project 91 there were no expansion joints. At a number of corner breaks on these two pavements, an examination showed that the edge bars had buckled and apparently caused the corners to fracture. A close-up view of one of these buckled bars is shown in Figure 23, A. The edge bars in this pavement were in continuous bond and extended across the expansion joints with no provision for relative movement of the steel with respect to the concrete at these joints.

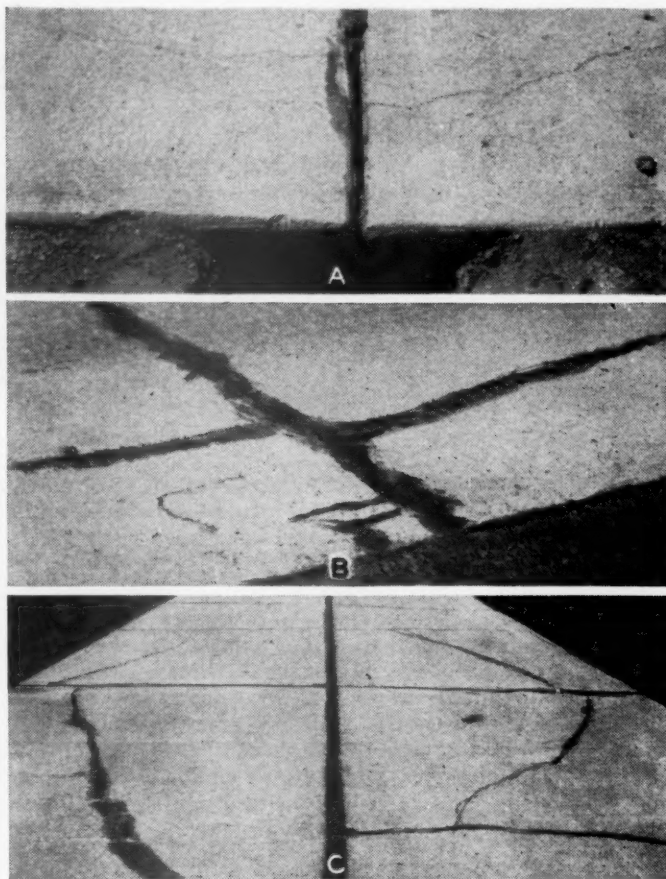
FIGURE 24.—A, INFILTRATION CRACK IN EARLY STAGE OF DEVELOPMENT IN REINFORCED PAVEMENT; B, TYPICAL INFILTRATION CRACK; C, TYPICAL INFILTRATION CRACKS THAT HAVE DEVELOPED TO A SERIOUS DEGREE.

"Infiltration crack" is a name that has been applied by engineers of the Michigan State Highway Department to a peculiar type of cracking found in many of the concrete pavements in Michigan. Figure 24 shows photographs of typical infiltration cracks.

Figure 24, A shows an early stage of development. Figure 24, B shows a more advanced stage while figure 24, C shows a number of these cracks that have developed to a serious extent.

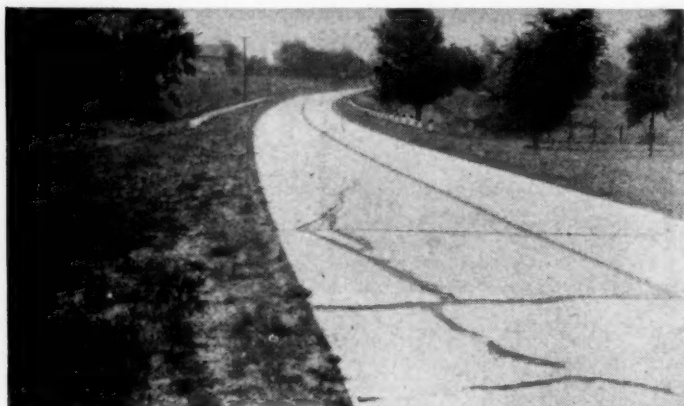
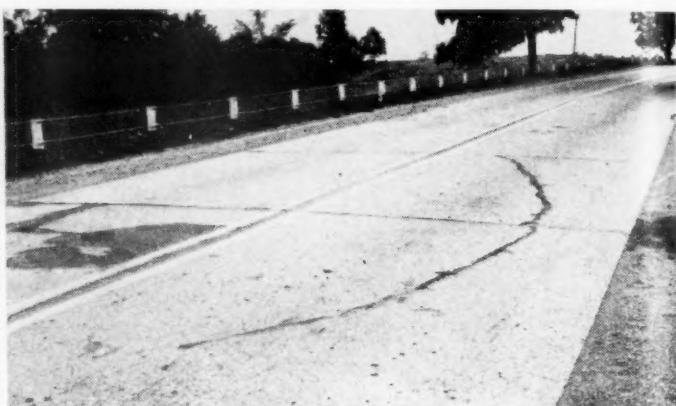
FIGURE 25.—INFILTRATION CRACKING ON STATE PROJECT 3924 C-1.

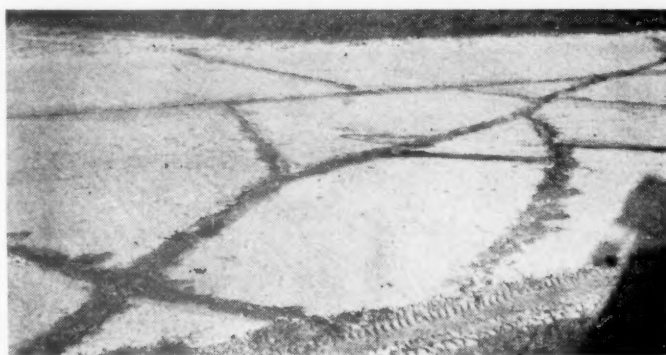
FIGURE 27.—CRACKING CAUSED BY DIFFERENTIAL FROST HEAVING AT INTERIOR OF PAVEMENT.

In the past, trouble with differential frost heaving had been experienced in the subgrades of pavements in the Upper Peninsula. Considerable effort was being made to prepare the subgrades for new pavements in a manner to avoid this trouble, but the steps taken apparently had not been entirely successful.

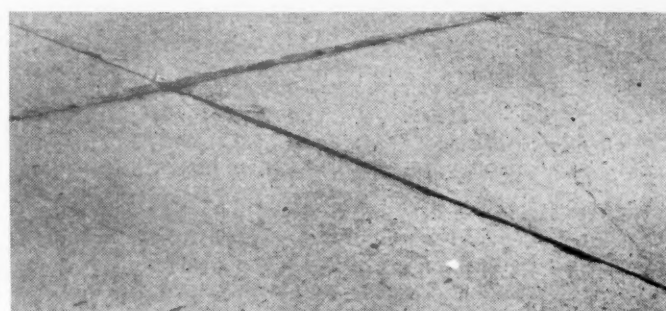
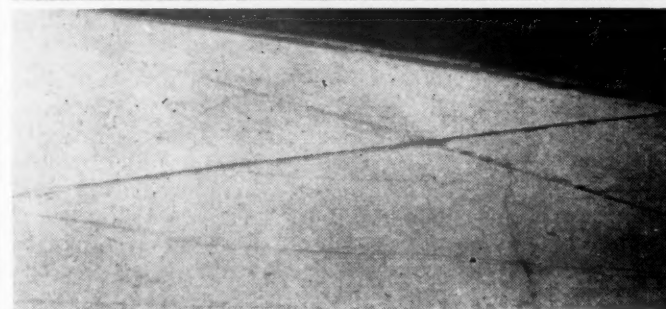
FIGURE 28.—CRACKING NEAR JOINTS CONTAINING LOAD-TRANSFER DEVICES THAT RESIST UPWARD FLEXURE.

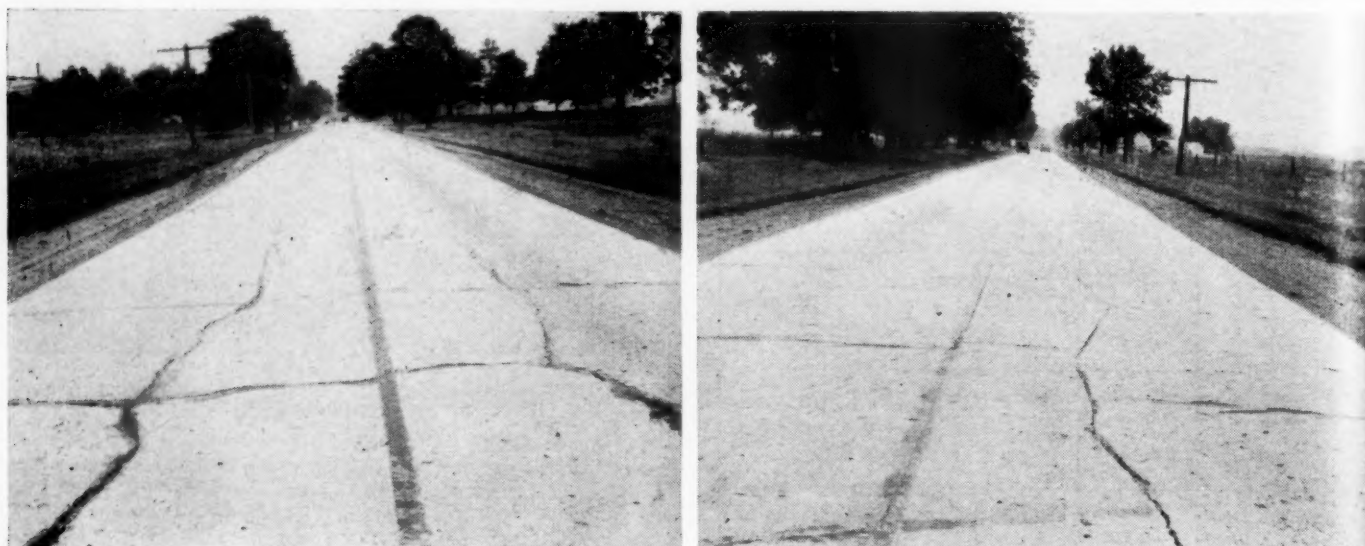
FIGURE 29.—LONGITUDINAL CRACKING IN PAVEMENT WITH RIGID LONGITUDINAL JOINT.
